## CHAPTER IV

# Achieving Seismic Safety in Lifelines

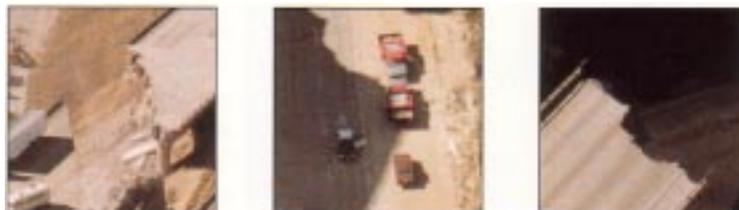
**% Roadbed sections of part of Interstate 5 fell off their supports.**

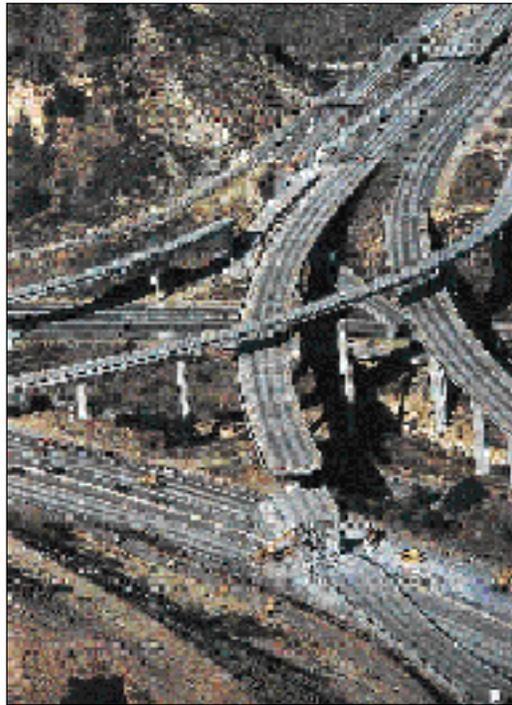
The interchange of State Route 14 and Interstate 5 (see Figure 68 for locations) was badly damaged in the 1971 San Fernando earthquake, but the two structures that collapsed in the Northridge earthquake, the North and South Connector overcrossings, were designed before 1971. At that time it was believed that improved hinge restrainers would be adequate to prevent collapse. Though they contain some pre-1971 design details, hinge restrainers were added to both bridges. During the Northridge earthquake, brittle shear failures in short stiff columns next to the abutments initiated the collapse of both bridges as shown in Figure 69. After the columns failed in shear and were crushed by the weight of the decks, the decks were pulled from their supporting abutments. As the decks fell, they failed by bending at the adjacent piers. These failures demonstrated that retrofitting such structures with hinge restrainers alone may not be adequate. Retrofitting the single-column piers to

prevent brittle shear, moment, and foundation failures may also be needed. Caltrans has incorporated this observation in the design of both retrofitted and new projects.

Figure 69. Two overpass collapses at the I-5/SR-14 interchange were started by failures in short, stiff columns.

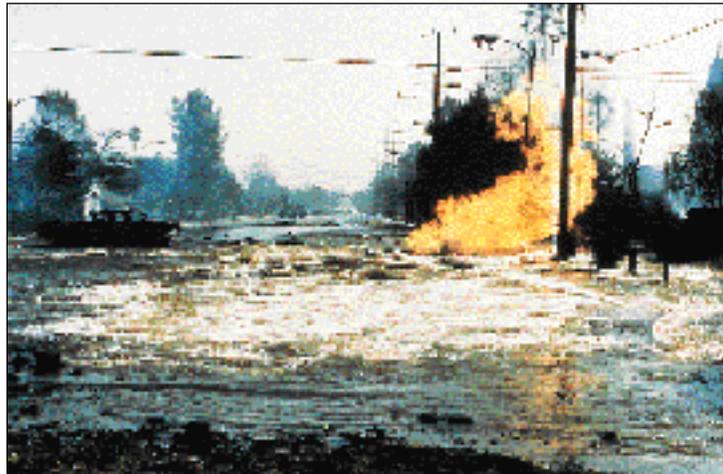
The Northridge earthquake also illustrated, as have previous earthquakes, that modern pipe of steel and other materials performs well even when subjected to intense shaking and moderate levels of ground displacement. Most of the problems in transmission pipe appear to have been related to weld failures in oxyacetylene-welded steel pipe installed before 1932, when welding procedures were inferior to those currently used (O'Rourke and Palmer, 1994). The natural-gas fire on Balboa Boulevard, Figure 71, was from an older pipeline in an area where significant ground deformation occurred; the resulting fire engulfed five nearby homes.

**Figure 71. Fire and flood produced calamity at Balboa Boulevard's ruptured gas and water mains.**

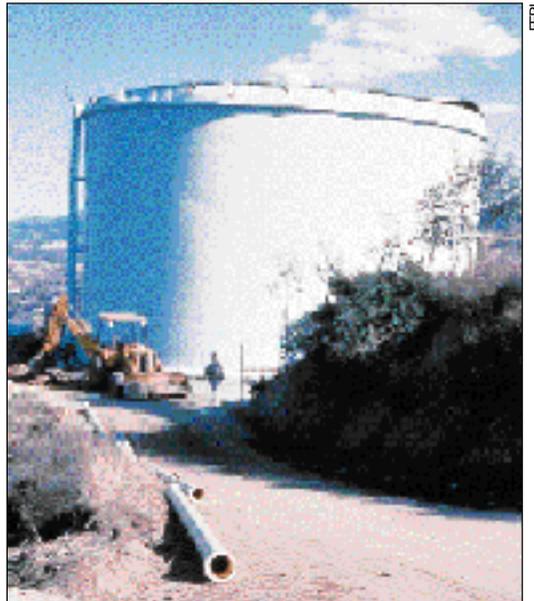
There was also extensive damage to older aboveground steel water tanks. In several cases, the entire contents of the tank were lost because of failures of inlet-outlet piping, which generally occurred because the ground shifted under the tanks. Other failures included buckling at the base of tanks, buckling of the shells, and roof damage. Because these storage facilities may represent the only immediate water supply for local systems, special measures must be employed to ensure their integrity after earthquakes (see Figure 72).

**Figure 72. The walls of this water tank buckled; pipes ruptured and lost 800,000 gallons.**

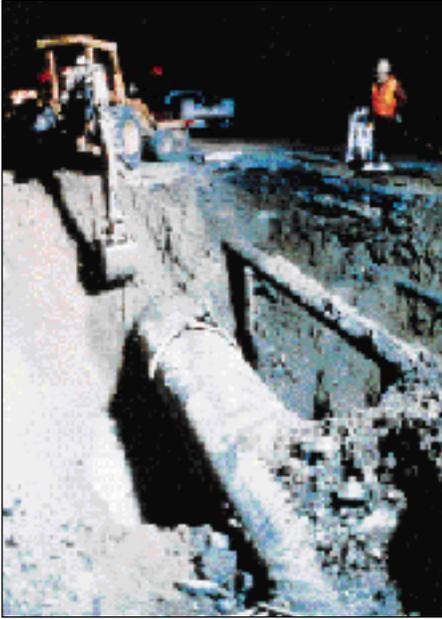
could be put out of service by a single event (Figure 73). Similar situations exist in northern California.

**Figure 73.** This four-foot-diameter water main under Balboa Boulevard buckled and ruptured when surrounding soils compressed it.
