A Comparative Study on the Seismic Preparedness of Hospitals Following Recent Damaging Events

The Impact of the 22nd February 2011 Earthquake on Christchurch Hospital

2012
NZSEE
Conference

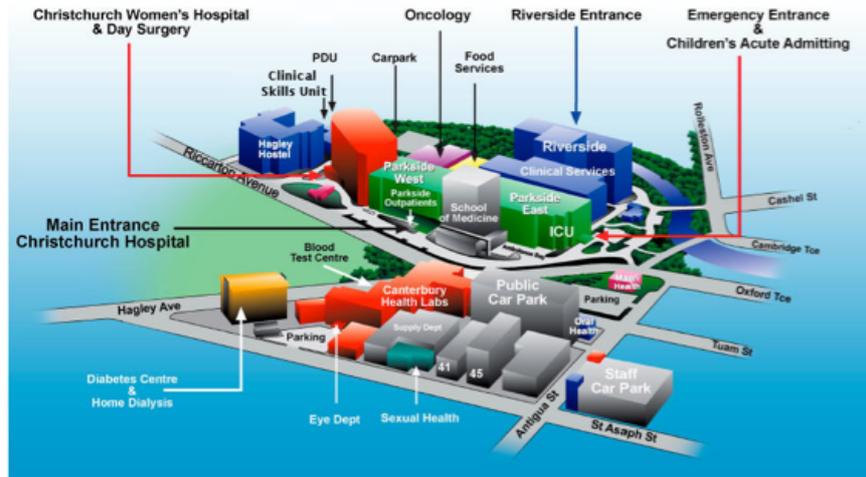
Figure 1. Layout of Christchurch Hospital

Christchurch Hospital is the largest hospital in the Canterbury Region and the centre of the region's healthcare system. Christchurch Hospital operates the only Emergency Department (ED) and Intensive Care Unit (ICU) in Canterbury and performs the majority of elective surgeries. The hospital serves the geographically largest health district (CDHB) in New Zealand, which includes a population of 560,000. The inpatient wards provide services to over 35,600 inpatients each year, of which approximately two-thirds are admitted acutely; a further 13,000 people are day patients. There are 16,000 theatre visits each year and over 197,000 outpatient attendances, excluding those for radiology

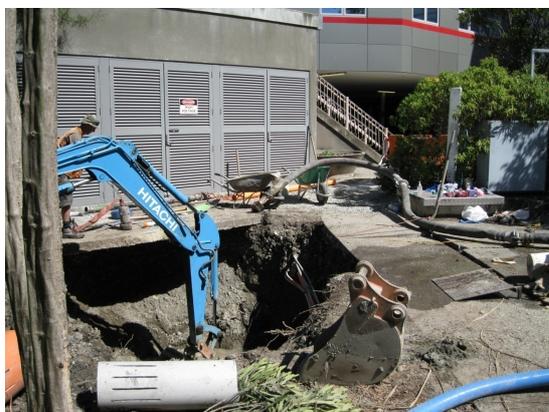
(a)

Geotechnical failures caused widespread damage to the hospital campus. For example, liquefaction caused flooding in the basements of all the buildings, including the Women's Hospital. The Parkside and Riverside buildings suffered the worst flooding. All the retaining walls between the river and the hospital failed, and the lateral spreading near the river caused severe damage to sewage lines (Figure 1a). Additionally, the tunnel that connects clinical facilities and non-clinical facilities across Riccarton Avenue was knee-deep in water after the earthquake.

Figure 1. Observed damage throughout hospital campus: a) liquefaction-induced damage to the main sewer line, and (b) damage to Riccarton underground tunnel (photo credit, Alan Bavis).

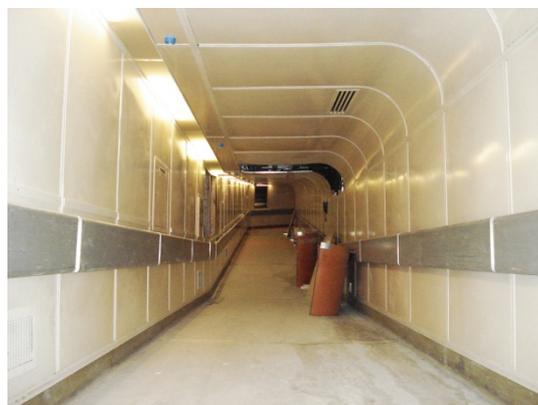
(b)

There were no catastrophic structural failures (i.e., local or global collapses) to any of clinical or non-clinical buildings of Christchurch Hospital that were operating at the time of the 22nd February earthquake. However, severe structural damage did cause some forced closures. For example, the underground tunnel carrying lifelines running below Riccarton Avenue was still unusable at the time of interviews (Figure 1b).

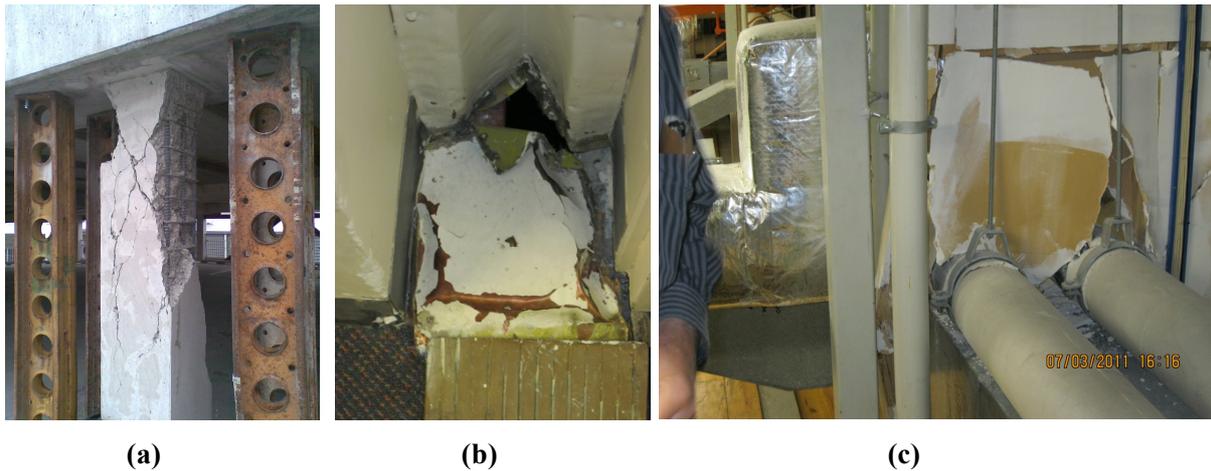
damage to the connection of the roof to the walls. The hospital's parking structure did experience extensive structural damage, including spalled concrete of its beams and columns and cracking of its steel bracing. The cost to repair the parking structure's damage is estimated to be NZ\$2 million. Figure 2a shows damage to concrete columns on the ground floor of the parking structure.

There was also widespread evidence of minor to moderate structural damage in several other buildings, including the Riverside Building, some non-clinical buildings, and the hospital's boiler stack. The Riverside Building, for example, suffered shear wall cracking, where some of these cracks went all the way through the wall. All clinical buildings suffered roof damage. Also several buildings experienced damage across separation joint and firewalls. Figures 2b and 2c show examples of damage found on the Christchurch Hospital campus, including damage to at a separation joint in the Riverside Building and damage to a firewall in the CWH, respectively.

Figure 2. Observed structural damage in non-clinical and clinical buildings: a) spalled concrete in ground-floor column of a parking structure, b) separation joint damage in Riverside Building, and c) damage to firewalls in the CWH (photo credit, Alan Bavis).
