## CHAPTER IV

# Achieving Seismic Safety in Lifelines

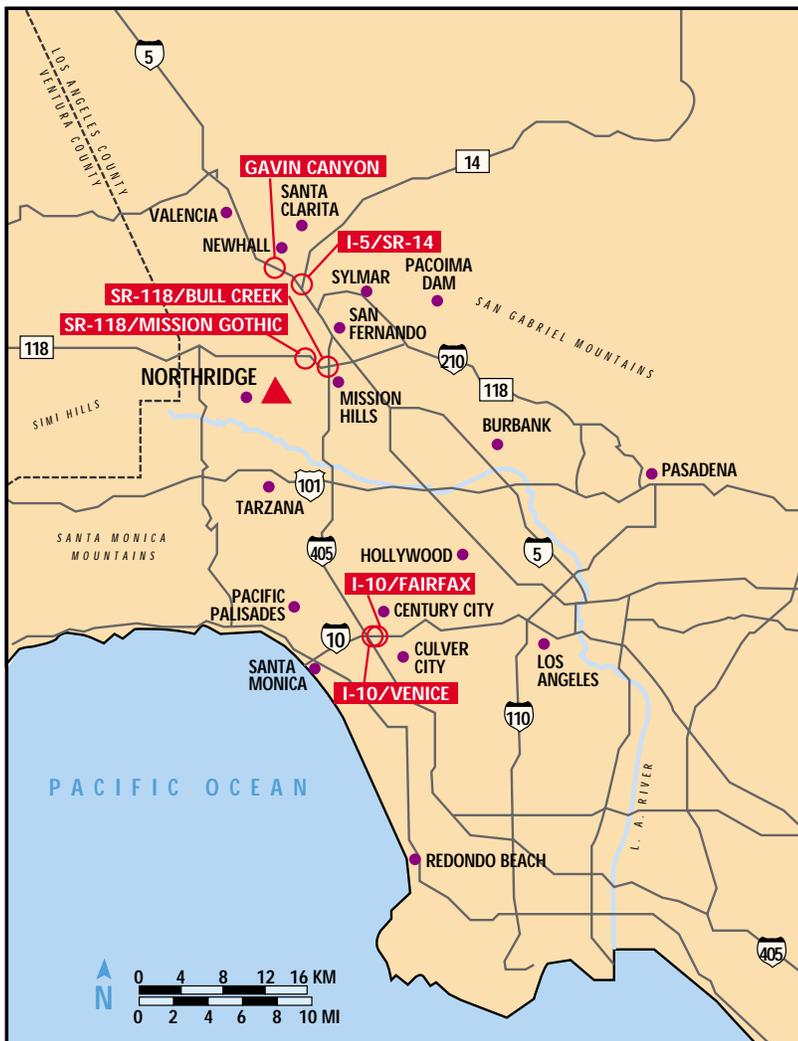
**Figure 68. Location of collapsed overpasses.**

The interchange of State Route 14 and Interstate 5 (see Figure 68 for locations) was badly damaged in the 1971 San Fernando earthquake, but the two structures that collapsed in the Northridge earthquake, the North and South Connector overcrossings, were designed before 1971. At that time it was believed that improved hinge restrainers would be adequate to prevent collapse. Though they contain some pre-1971 design details, hinge restrainers were added to both bridges. During the Northridge earthquake, brittle shear failures in short stiff columns next to the abutments initiated the collapse of both bridges as shown in Figure 69. After the columns failed in shear and were crushed by the weight of the decks, the decks were pulled from their supporting abutments. As the decks fell, they failed by bending at the adjacent piers. These failures demonstrated that retrofitting such structures with hinge restrainers alone may not be adequate. Retrofitting the single-column piers to

prevent brittle shear, moment, and foundation failures may also be needed. Caltrans has incorporated this observation in the design of both retrofitted and new projects.
