Findings and Recommendations

San Simeon Earthquake of December 22, 2003

CALIFORNIA SEISMIC SAFETY COMMISSION
CSSC No. 04-02

May 5, 2004

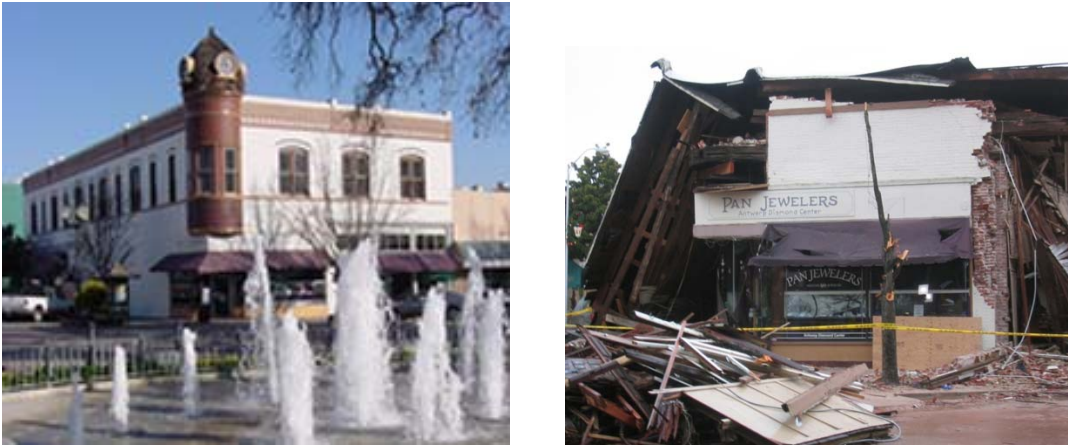
Figure 1. Paso Robles' Landmark, the Acorn Clock Tower Building before and after the earthquake. (Photo: www.PanJewelers.com and EERI, Josh Marrow)

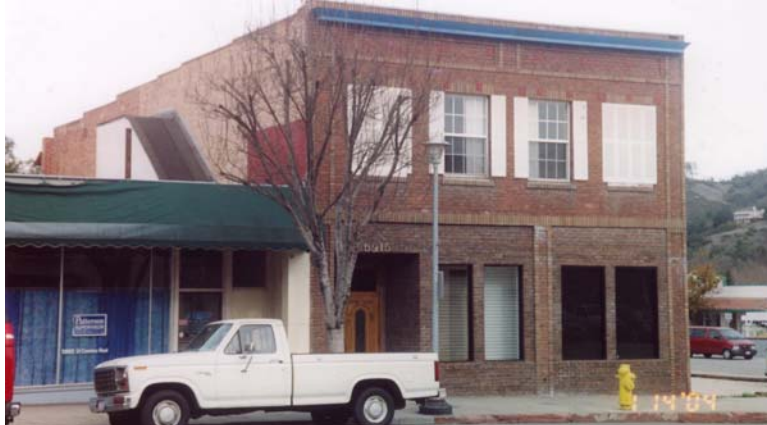
The San Simeon earthquake demonstrated the effectiveness of retrofitting URM buildings. Downtown Paso Robles has 53 URM buildings of which 9 have been retrofitted. None of the retrofitted buildings suffered major damage while many of the unretrofitted buildings sustained enough damage to require them to be demolished.

Figure 2. Retrofitted unreinforced masonry buildings such as this one in Atascadero generally performed better than nearby unretrofitted or partially retrofitted buildings. (Photo: CSSC)

Recommendation No. 1: Local Governments in Seismic Zone 4 should adopt effective retrofit programs to be completed within the next 5 years. Retrofits should at a minimum comply with the 2003 International Existing Building Code Appendix Chapter 1.

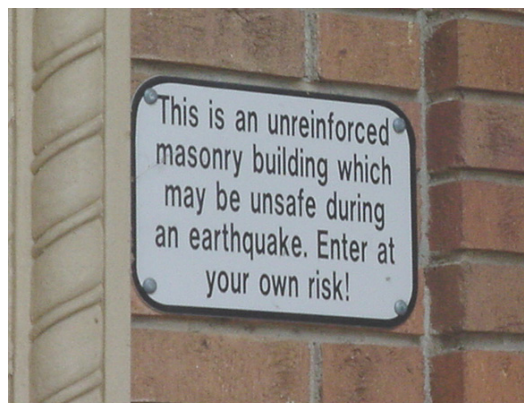
State legislation in 1992 required owners to post placards at entrances to URM buildings. This law has also proven ineffective because it lacks an enforcement mechanism. It is also unfair to owners who have already retrofitted because they can’t remove the placards, and it fails to ensure that occupants know how to protect themselves in buildings during earthquakes.

Figure 3. The Printery Building in Atascadero is one of the few buildings in the region with a placard. The building was damaged and closed following the San Simeon earthquake. (Photo: EERI, Abe Lynn)

Recommendation No. 2: The state’s existing URM placarding law is ineffective and should be improved by:

- **Imposing fines for non-compliance;**
- **Requiring warning signs to clearly describe where occupants can find more information about their building’s risks and recommendations for appropriate actions to building occupants when earthquakes occur; and**
- **Allowing URM building owners to remove placards after completing retrofits that comply with the state’s minimum standard. Alternatively, owners should also be allowed to post substitute signage indicating that the building has been retrofitted.**
